Five-year clinical retrospective study

Survival and treatment success of full-arch implant-supported PEEK prostheses

DR BERND SIEWERT, POZUELO DE ALARCÓN, SPAIN

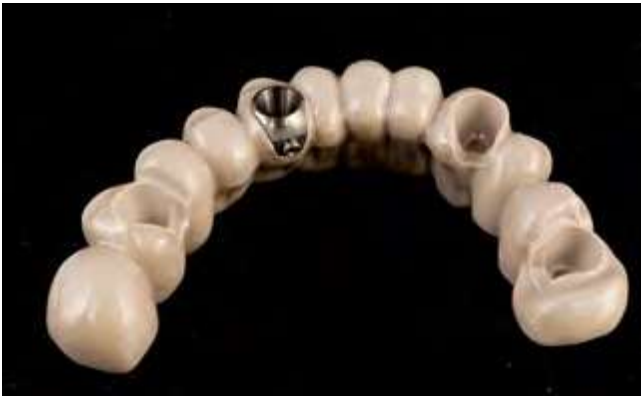
1 | Laboratory intaglio view of a PEEK framework with one of the four horizontal screw titanium abutments in place.

All patients were treated with full-arch implant-supported screw-retained (horizontal (Fig. 1) or occlusally retained (Fig. 2) bridges with PEEK frameworks. The PEEK surface was sandblasted with 80 µm aluminium oxide at a pressure of 2,5 bar and treated with a Primer (Visio-Link; Bredent, Senden, Germany). The framework was then veneered with pre-fabricated multilayer PMMA composite veneers (novo.lign; Bredent) using a

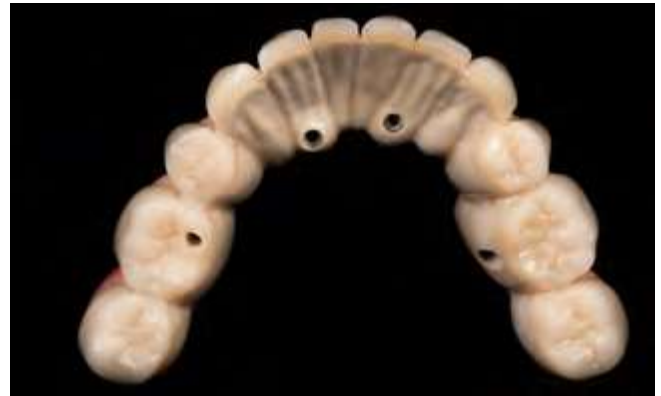
2 | Laboratory occlusal view of a veneered PEEK framework with four occlusal screws.

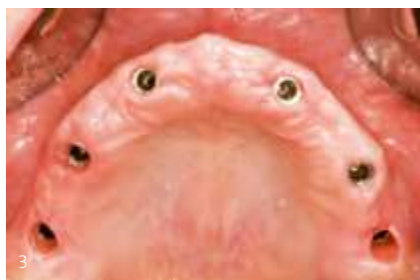
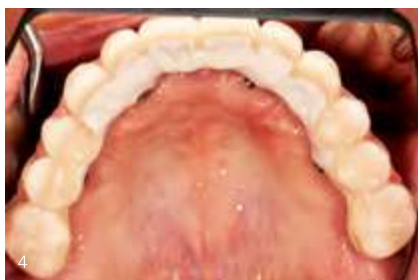
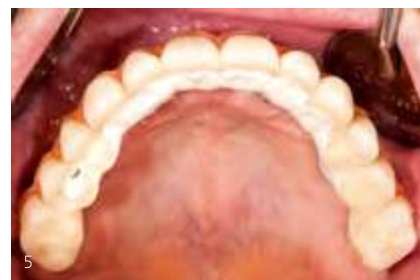
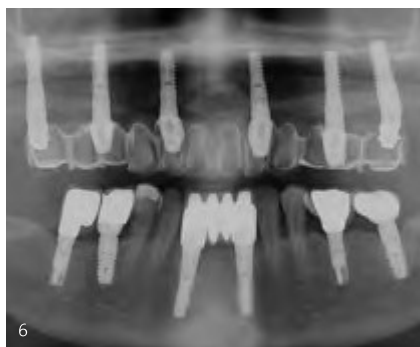
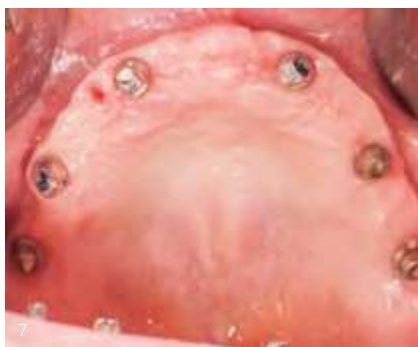
- 3 | Initial situation prior to prosthesis delivery, occlusal view (June 2008).
 4 | Full-arch screw-retained prosthesis with PEEK framework in place, occlusal view (June 2008).
 5 | The same prosthesis at the recall appointment eight years later (October 2016).
 6 | Panoramic radiograph at the recall appointment eight years after insertion (October 2016).
 7 | Situation with prosthesis removed at the recall appointment eight years after insertion (October 2016).

part attached in the molar region, one patient wore a full-arch metal-ceramic restoration, two patients had their natural dentition and the remaining twelve patients wore single or crown or short ceramic bridges restorations on natural teeth or implants. Figures 3 to 7 demonstrate a representative case over the observation period.

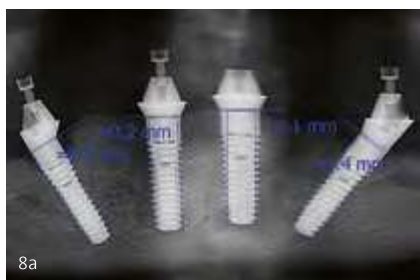
8 | Representative example case for the measurement protocol of the mesial and distal peri-implant bone levels in detail of the panoramic radiography | a: Initial reference when the definitive restoration was installed after calibration process (September 2013) | b: Final reference at the end of the observation period after calibration process (November 2016).

each patient included in the study at the end of the observation period. As the study is a clinical retrospective one, the radiographs were only standardized to the extent that they were done using the same machine operated by the same person and following a strict positioning protocol. Digital data was then analyzed with the dental imaging software Cliniview (Kavo Dental, Biberach, Germany) using the following protocol: Each image was optimized by adjusting brightness, contrast and gamma. Each image was then calibrated prior to the length measurements of the mesial and distal aspect (Figs. 8a and 8b). To improve measurement accuracy, the region to be measured was adequately amplified. The distance between the implant shoulder line and the crestal bone line was measured in the distal and mesial sides of the implant.

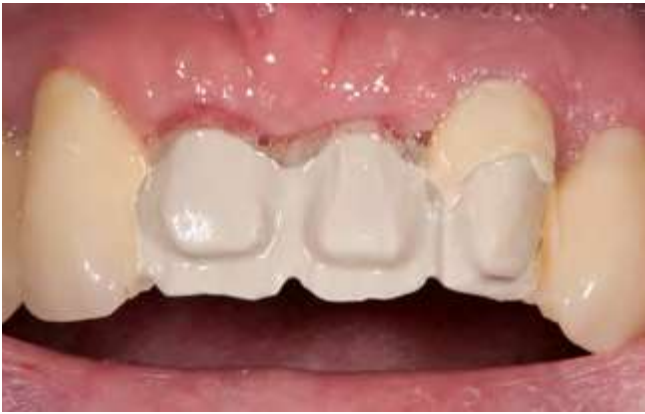
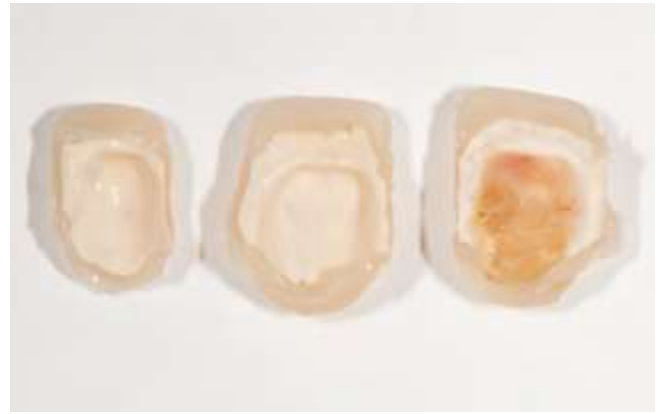
9a & b | Examples of early veneer chipping (within the first month of placement), due to bonding process in the laboratory.

No prosthetic complications such as abutment corrosion, abutment decementation or screw loosening were observed. Veneer chipping occurred in five cases and could be divided into two groups. The first group included 2 cases of early chipping within the first month after bridge placement, due to a mistake in the bonding process (Figs. 9a and 9b). Following repair in the dental laboratory, no more instances of this kind of chipping were observed. The second group included 3 cases of so-called late chipping, single-veneer fractures after

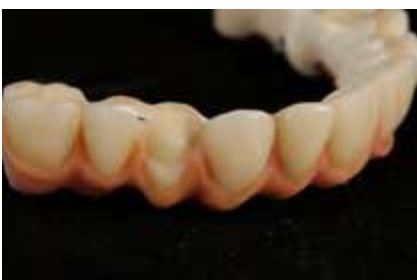
10 | Examples of late veneer chipping, six years after placement, caused by occlusal abrasion of the PMMA veneers.

several years of use, due to changes in the occlusal pattern (Fig. 10); it only occurred in the subgroup of bruxers, and all 3 cases could be repaired at chairside in the dental office.

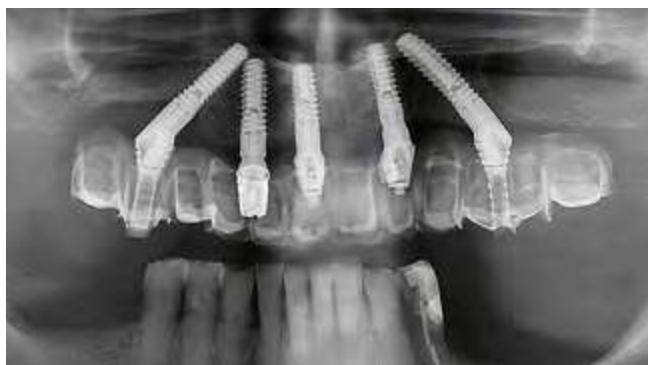
11a | Panoramic radiography of a patient with bruxism at four months follow-up after prosthesis placement.

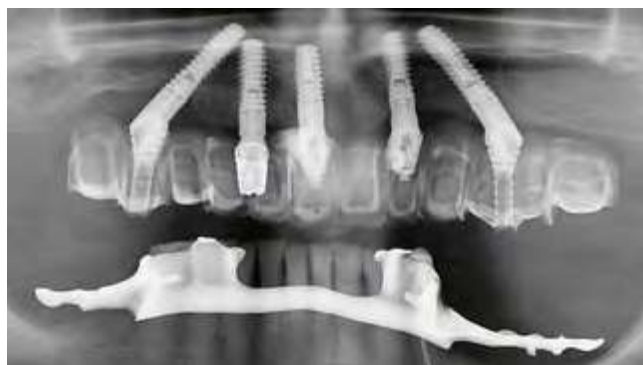
11b | Panoramic radiography of the same patient at 70 after prosthesis placement.
